## West Highland Way - multi-use access

### Milngavie to Drymen

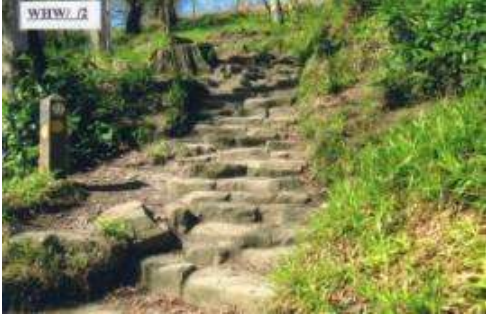
Location / OS Grid Ref.	Feature/description	Alternative access to avoid Restrictions
Craigie Fort NS417908	Steep, rocky path winding up to viewpoint with stone steps.	Narrow lochside path impassable by horses due to narrow metal bridge 28m x 1.1m with metal grid deck) and numerous steps. Alternative is public road.

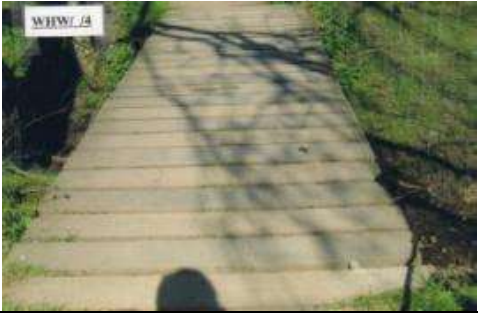
<p>Steep, rough, winding path with some steps leads back down from viewpoint</p>	
<p>NS416914 North of Arrochymore Point</p>	<p>Slatted wooden footbridge 5m x 1.4m, alternate planks non-slip</p>

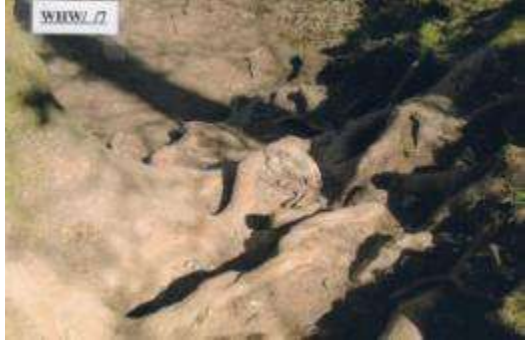
<p>NS411919</p>	<p>Exposed tree roots on steep rough path</p>

<p>Follow public road</p>
<p>NS398937 North side Lag an Amair Wood</p>	<p>Wooden bridge 7m x 1.45m, four steps down at northern end</p>	<p>Follow public road</p>
<p>NS386951 Carn na Muice</p>	<p>Rough rocky steps</p>

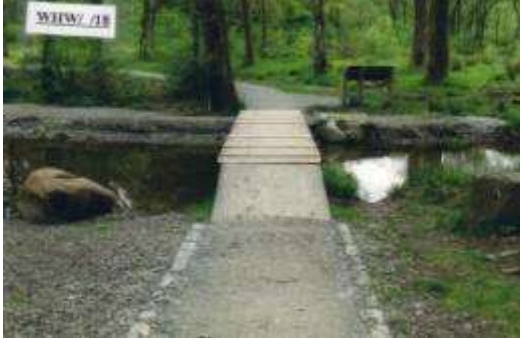
<p>NS379958 Allt a Mhuitinn</p>	<p>6m x 1.2m wide wooden slatted footbridge, no railings, concrete ramp either end</p>

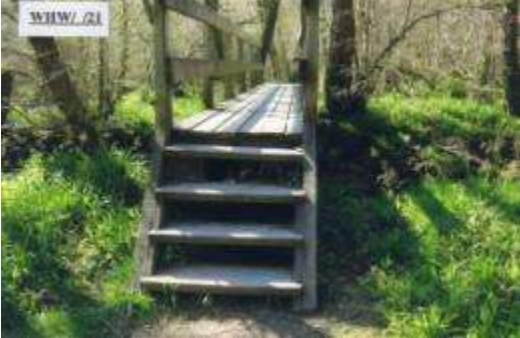
NS367971	<p>12m x 0.85m wooden bridge, 4 steps one end and 5 the other</p>

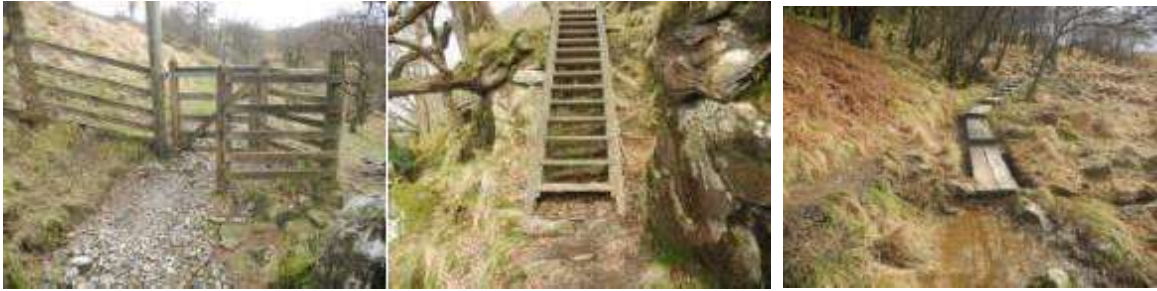
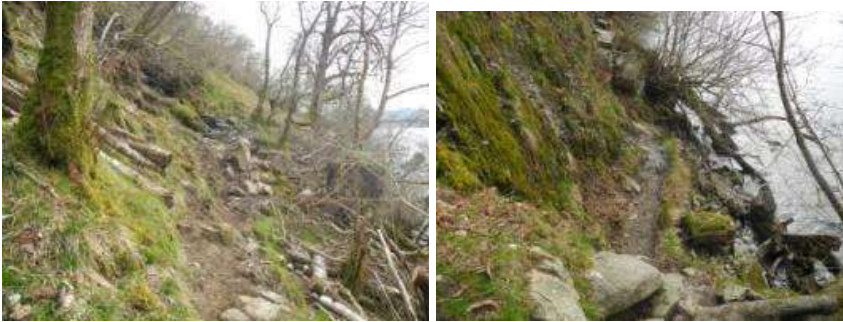
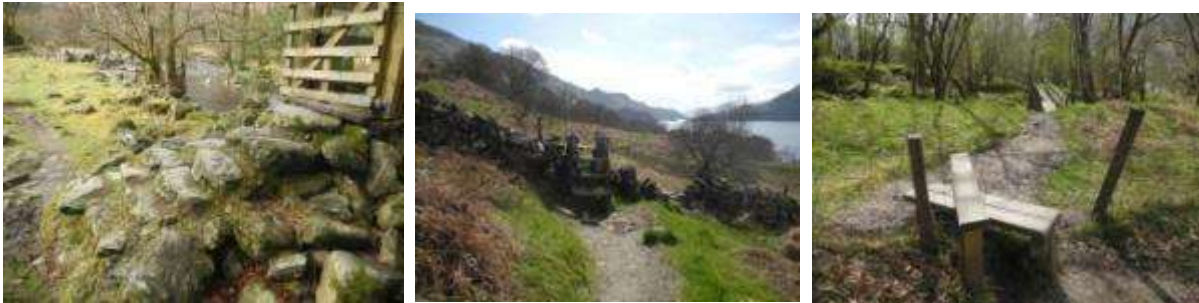
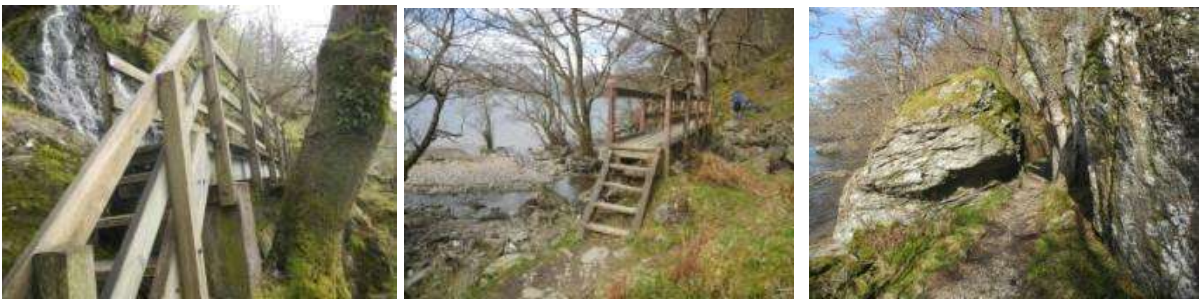
This section of the West Highland Way is well-known for being the most taxing even for walkers. Although some parts of it might in theory be multi-use accessible, numerous natural and man-made features make it impassable with a horse and very difficult with a bike. The path takes the line of least resistance, often following a narrow strip between crags and loch, with a precipitous slope on either side, in some places restricted by large boulders which would be difficult if not impossible to pass with a horse, in others across boggy ground. Stepping stones over burns have been sited at the easiest crossing, which all too often does not coincide or easily link with somewhere horses might more easily ford or jump across the burn. In various places where steps have been constructed up steep slopes, there is no alternative way round, nor space to pass alongside. Narrow footbridges with steps either end, kissing gates, stiles and open slatted boardwalks present further restrictions and obstructions, albeit academic given the nature of the remainder of this section. In view of the number of restrictions and impassability with a horse, and the lack of link or loop paths to enable use of smaller parts of this section, individual obstructions have not been individually listed.

The footbridge over the Ben Glas burn is too narrow for horses, but there is a ford 20 metres west downstream.

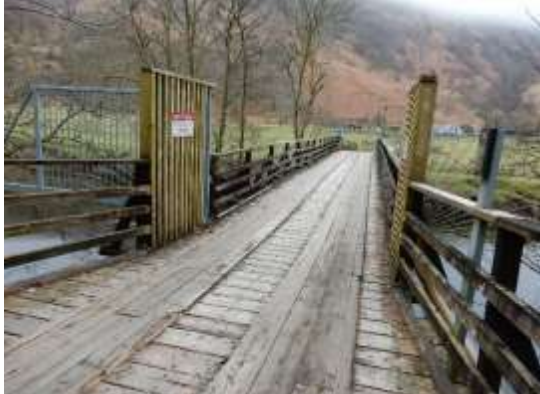
Location / OS Grid Ref.	Feature/description	Alternative access to avoid restrictions
<p>NN319188 Link path between A82 and West Highland Way north of Drovers Inn</p>	<p>Wooden vehicle bridge. Gates locked 11 pm – 7 a.m.</p>

<p>None.</p>
<p>NN319187 east side River Falloch bridge</p>	<p>Waymarked West Highland Way turns off track through kissing gate. Several boggy sections and fallen trees, impassable with a horse.</p>

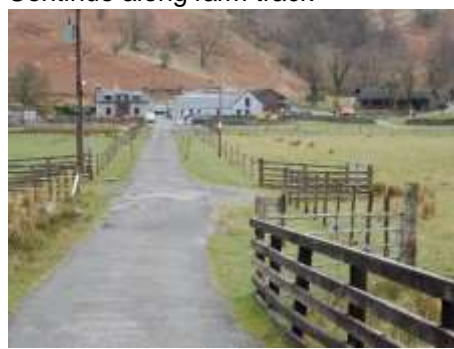
<p>NN321186 link path along north side Ben Glas burn</p>	<p>Further kissing gate</p>

<p>Use farm track as above</p>
<p>NN327201</p>	<p>Stile in fence. Gate 5 m east unlocked at time of survey. Narrow footbridge immediately beyond</p>	<p>Ford immediately adjacent downstream</p>

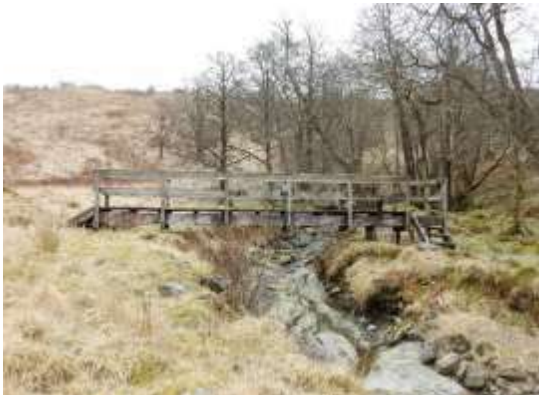
<p>NN327202</p>	<p>Narrow wooden footbridge with 3 steps either end (southern end broken at time of survey) impassable with a horse. Difficult to ford burn because of rock slabs</p>

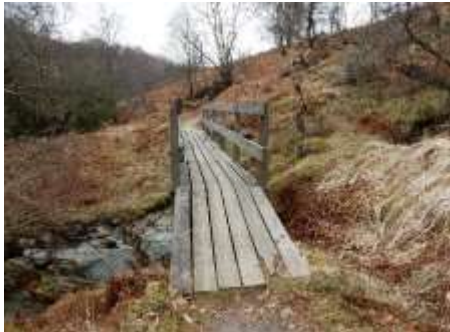
<p>NN333206</p>	<p>88cm wide wooden footbridge, some rotten planks, impassable with a horse</p>

<p>Very difficult to ford due to terrain, rocks and trees</p>
<p>NN334206</p>	<p>84cm wide wooden footbridge, railed one side, some rotten decking planks</p>

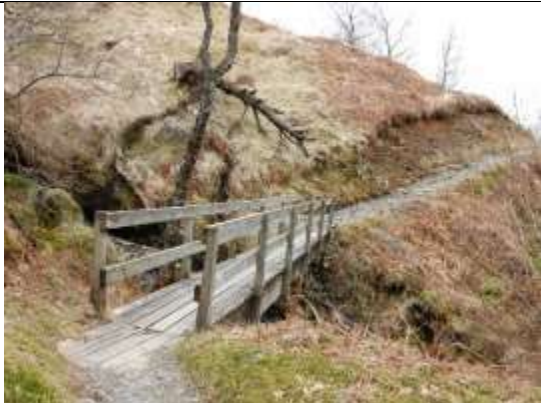
<p>None due to rocks and trees</p>
<p>NN338208</p>	<p>88cm wide wooden footbridge, railed both sides, some rotten decking planks</p>	<p>Very difficult to ford deeply incised burn</p>

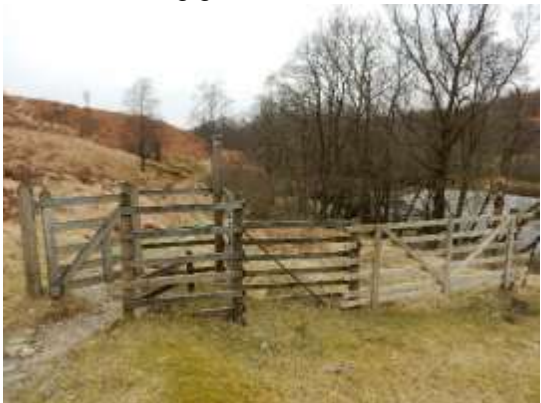
<p>NN340209</p>	<p>Wooden kissing gate</p>

<p>Wooden slip hurdle alongside</p>
<p>NN344214</p>	<p>Wooden kissing gate, 10' metal gate adjacent, unlocked at time of survey</p>

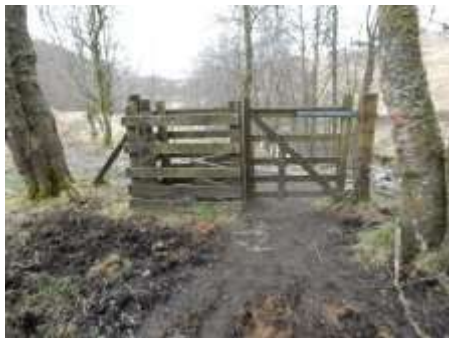
<p>NN353219 Northern end of wood north of Derrydarroch</p>	<p>Wooden kissing gate</p>

<p>None other than following Derrydarroch track out onto A82</p>
<p>NN359228</p>	<p>1.4m high underpass/sheep creep under railway</p>	<p>There may be potential to use the track west of the A82 linking onto it north of Derrydarroch farm track entrance but not surveyed</p>

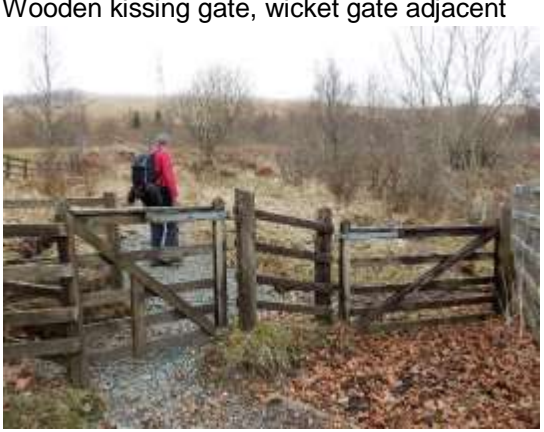
<p>NN359228 railway underpass near Carmyle Cottage</p>	<p>Wooden kissing gate, wicket gate adjacent</p>

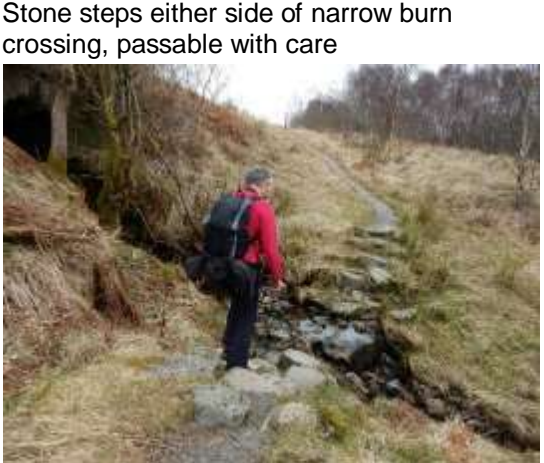
<p>NN359230</p>	<p>Stone steps either side of narrow burn crossing, passable with care</p>

<p>None</p>
<p>NN360230</p>	<p>Wooden stile over fence leading onto path under underpass</p>

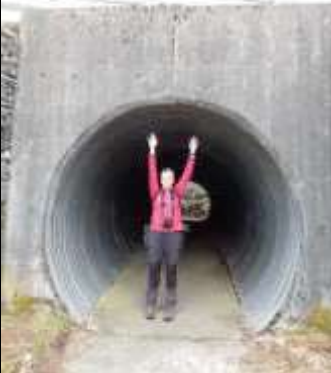
<p>NN359230 A82 underpass</p>	<p>Potentially passable with care dismounted</p>

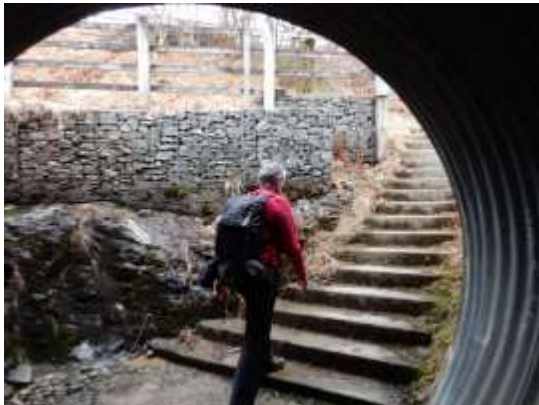
<p>NN359230 West side A82 underpass</p>	<p>Long flight of stone steps</p>

<p>None other than using track west of A82 from Derrydarroch (pictured below right looking south from junction with West Highland Way at Caisteal Rab)</p>

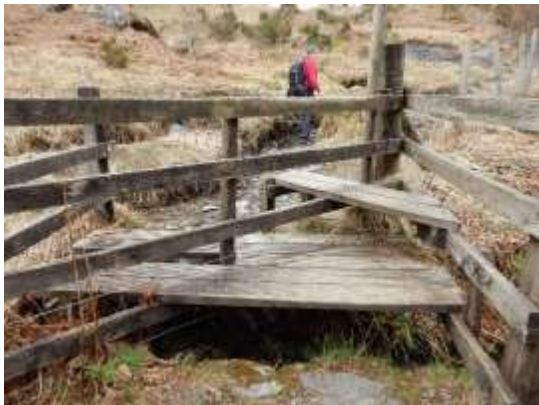
<p>West side A82 underpass</p>	<p>Wooden stile</p>

<p>As above</p>
<p>NN364240</p>	<p>Wooden stile over fence</p>

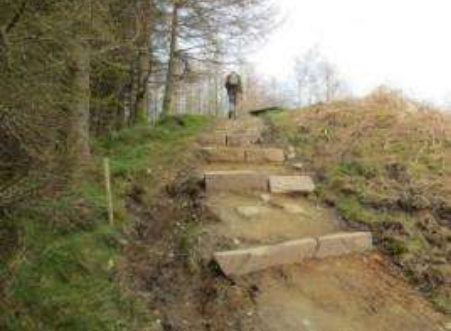
Location / OS Grid Ref.	Feature/description	Alternative access to avoid restrictions
<p>NN375251</p>	<p>Stone steps</p>

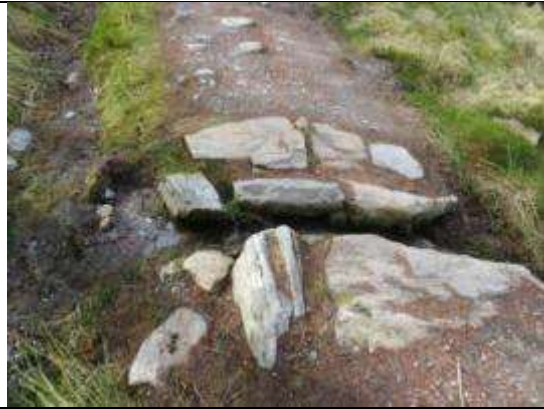
<p>NN373252 and 368254</p>	<p>Stone drainage channels in line of path passable with care</p>

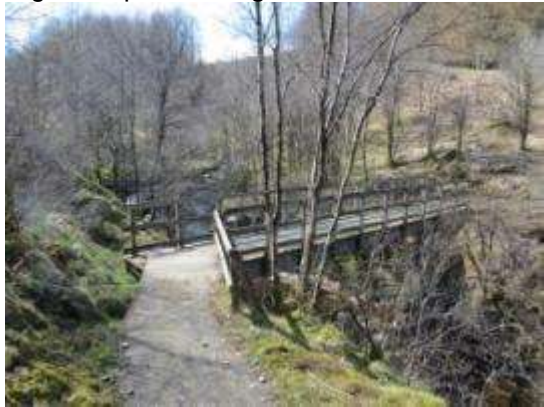
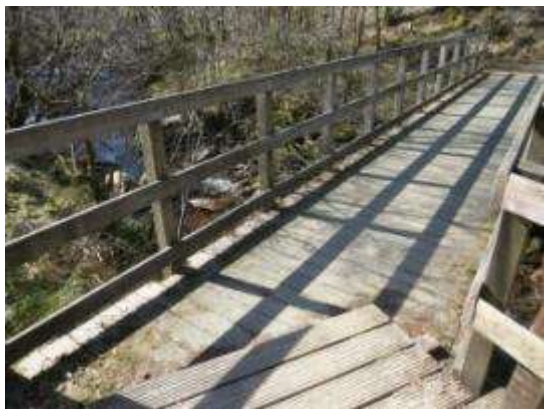
NN364259

Wooden bridge 1.5m wide, non-slip surface, angled step onto bridge

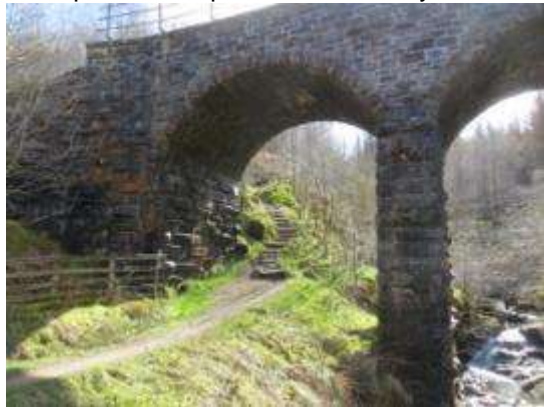
NN360275

14 steps down to pass under railway viaduct

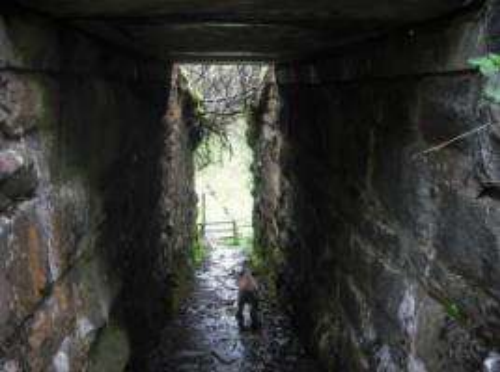
Location / OS Grid Ref.	Feature/description	Alternative access to avoid restrictions
NN327335	<p>Narrow railway underpass 1.2m wide x 2.2m high with some overhanging tree roots further restricting width. Passable with care if dismounted but some horses may dislike. On west side of underpass steep stone paved section leads down to locked gate across track adjacent to stile.</p>

<p>As the underpass is the only means of crossing the railway line, the only alternative to avoid the locked gate is to ride up the very busy A82 from NN332318, rejoining the West Highland Way via a field gate at NN328331. Argyll and Bute Council have been approached to replace the stile with a bridlegate (or locked gate with a 2-in-1 gate) and to pursue proposed installation of a multi-use bridge with ramps either end across the railway, but Implementation has yet to be timetabled.</p>

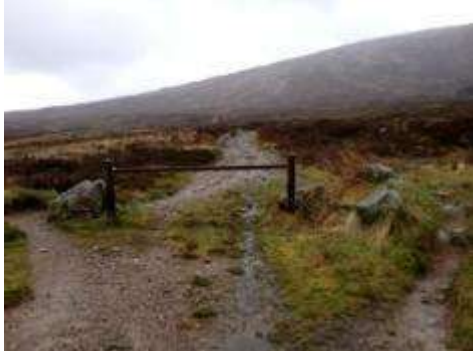
Location / OS Grid Ref.	Feature/description	Alternative access to avoid restrictions
<p>NN270526</p>	<p>Locked metal barrier to stop illegal vehicular access</p>

<p>Ample space for cyclists and horse-riders to get around side. Mobility buggies might find it more difficult.</p>

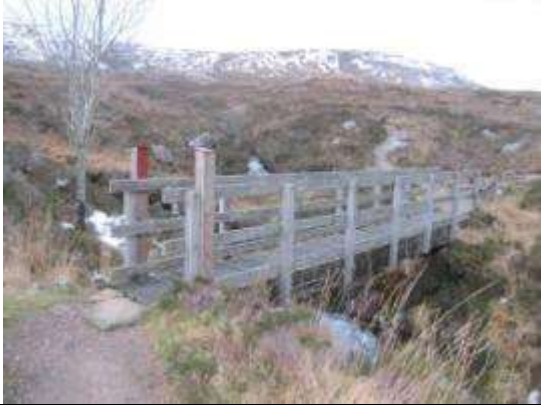
Location / OS Grid Ref.	Feature/description	Alternative access to avoid restrictions
NN220566	<p>Narrow wooden footbridge across steep rocky gully – passable with care with a horse but usually requires removing tack. Nowhere to safely tie horse while transporting tack across bridge</p>

<p>In dry weather it may be possible to ford the burn upstream</p>
Devils' Staircase	<p>Steep, narrow, rocky path, paved in places, with open cross drains – passable with care but horse-riders and cyclists should take particular care to respect other users</p>
